# The multiple land degradation effects of land-use intensification in tropical steeplands: A catchment study from northern Thailand<sup>1</sup>

Turkelboom F.<sup>1</sup>, Poesen J.<sup>2</sup> and Trébuil G.<sup>3</sup>

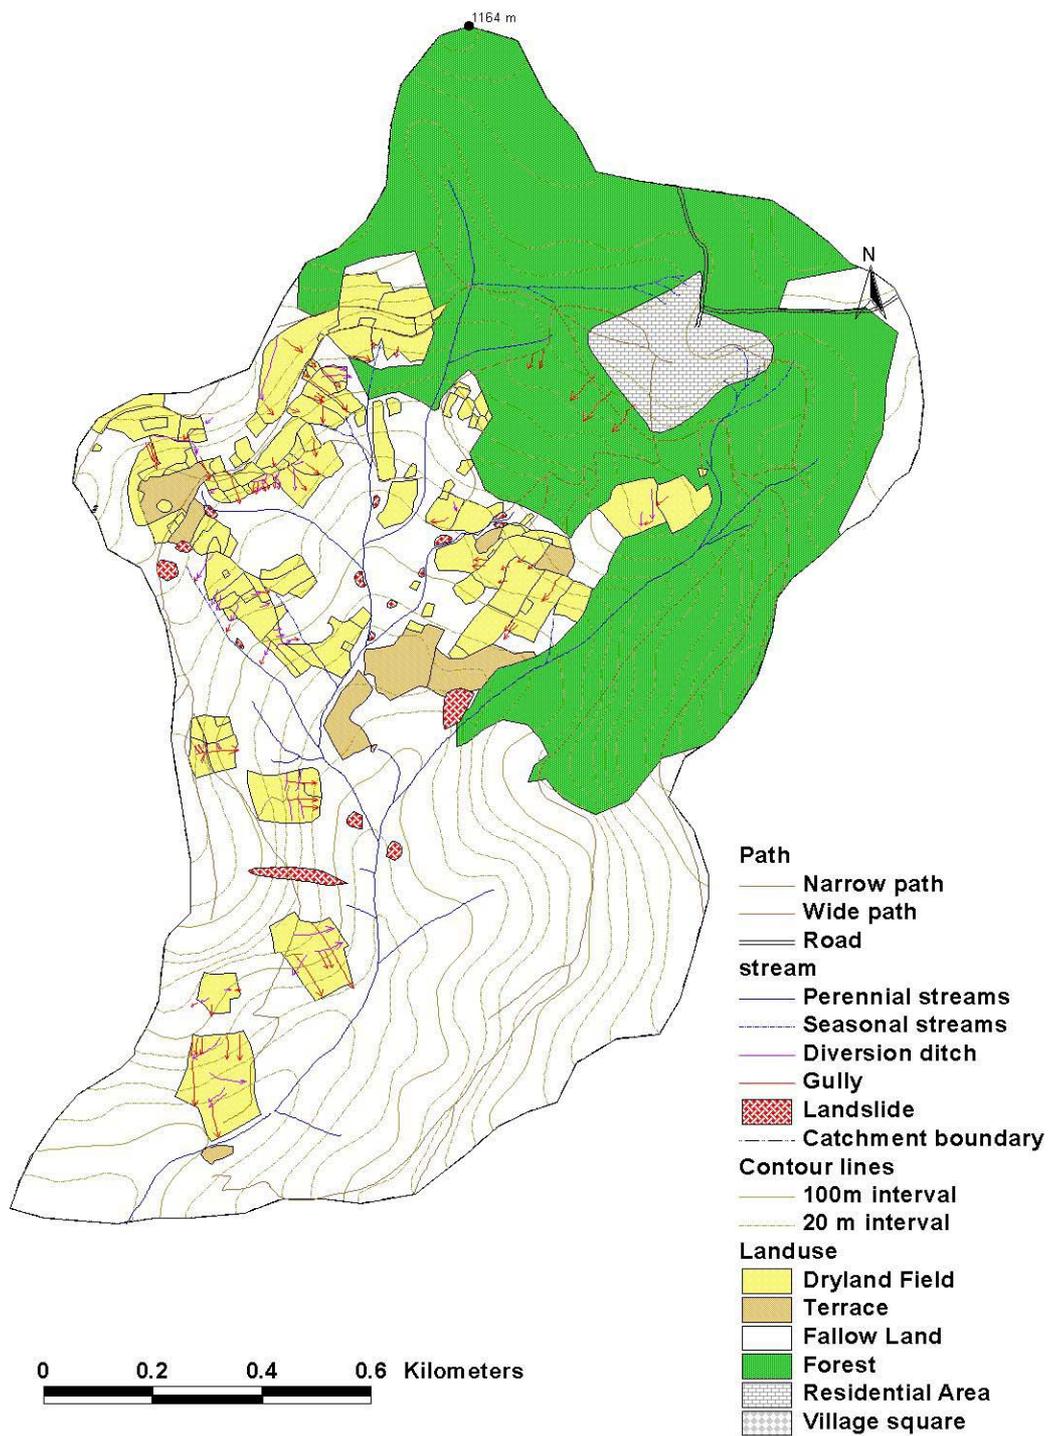
Figure 2. Topographic map of the 168 ha Dze Donglo catchment during the 1995 rainy season with indication of land-use, gullies and landslides (Pakha village, Chiang Rai Province, northern Thailand).

Gully erosion is quite common at the Dze Donglo catchment: nearly half of the observed fields experienced gully erosion (28 fields out of 59, Fig. 2). For the whole catchment, 2.3 km of gullies were measured, which represents an estimated soil loss of 423 ton/year at the catchment level (assuming an average gully depth of 30 cm, gully width of 50 cm and a bulk density of 1.2 kg/dm<sup>3</sup>). Gullies were found at natural drainage lines (valley-bottom gullies) and at hillside slopes (valley-side gullies). Two major scenarios of gully development were identified:

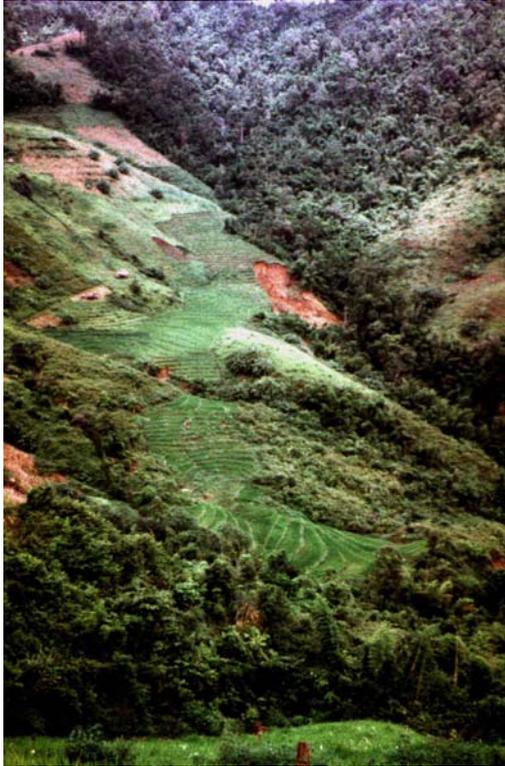
Figure 3. Land use of Dze Donglo catchment showing the patchwork of field parcels and a large rotational debris flow in the terraced area (Pakha village, Chiang Rai Province, northern Thailand).

Vertical stream incision causes over-steepened slopes along the streams, which can cause translational debris slides in fallow land and debris flow of paddies. A dramatic example of the latter is the massive landslide in paddy fields along the eastern stream (Fig. 3). A slide resulted in the loss of about 1000 m<sup>2</sup> of paddy land and 4800 m<sup>3</sup> of soil (or 65% of the total soil volume displaced by landslides during 1994). About half of the runoff from the 2.4 ha residential area drains into the eastern stream, and is assumed to have caused vertical incision of this stream. The coincidence of steep riverbank slopes with an adjacent large water saturated paddy area made this area a potential hotspot for landsliding.

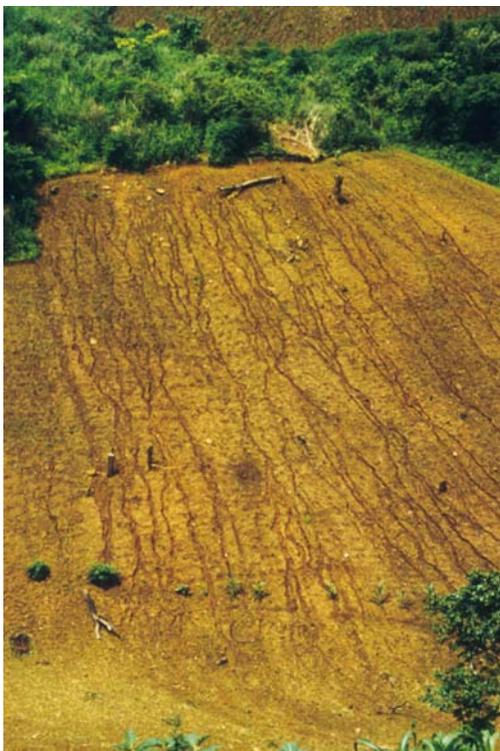
Figure 4. Rill erosion at one of the monitoring plots used during the plot level erosion survey (Pakha village, Chiang Rai Province, northern Thailand).

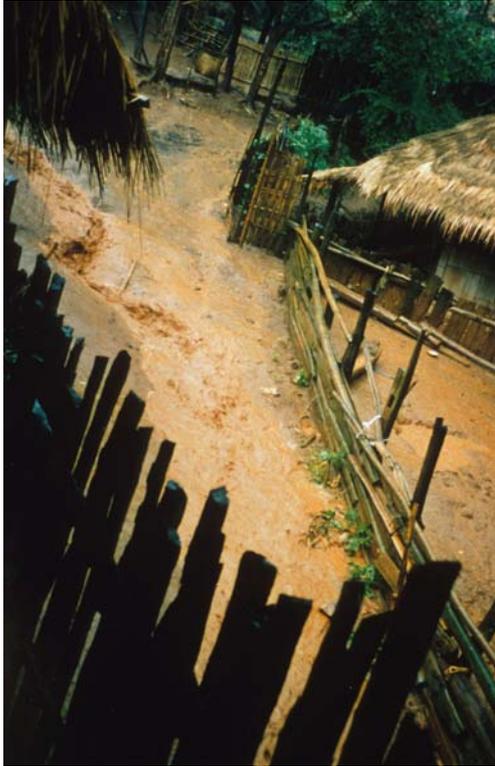
Figure 5. Compacted foot paths resulting in a high response runoff and sediment generation (Pakha village, Chiang Rai Province, northern Thailand).

Upper catchment connectivity: In the upper reaches of the Dze Donglo catchment, footpaths are the most important modifiers of the natural hydrological pathways, because they can easily transfer runoff from one spot to another, and because they can generate runoff by themselves. The infiltration capacity of foot paths is assessed to be less than 10 mm/hour, leading to quick-response Hortonian overland flow. Despite their compacted surface, they still generate significant sediment (Ziegler *et al.*, 2000). In the 1.68 km<sup>2</sup> study catchment, footpaths had a total length of 9.4 km (or 5.6 km footpath/km<sup>2</sup> catchment). Field observations made immediately after storms confirmed that runoff from one location can flow several hundreds meters down the slope via wide and gentle sloping footpaths and discharge at topographic low points (or discharge nodes) into lower (unprotected) fields (Fig. 5). Similar runoff pathways were observed in north-western Europe by Evans and Morgan (1974) and Watson and Evans (1991).

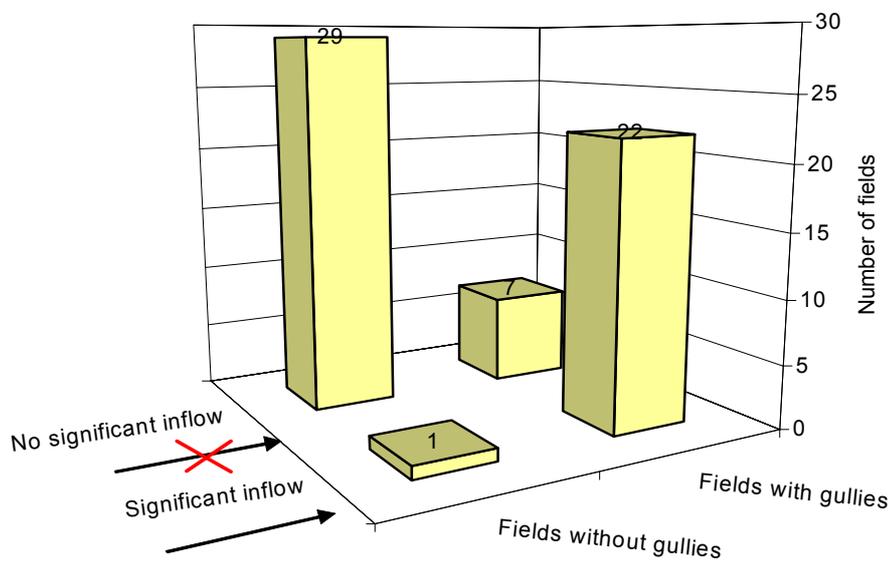
Figure 6. Relationship between significant runoff inflow (run-on) and gully development at field level in the Dze Donglo catchment during the 1995 rainy season (Pakha village, Chiang Rai Province, northern Thailand).

Run-on to fields: Due to the patchwork pattern of the fields, about 60% of the fields in the catchment are free from significant run-on (Fig 6). By far the most important landscape feature that provides protection against run-on is fallow vegetation, followed by agricultural infrastructure (such as terraces, diversion ditches, irrigation channels, and paths). As a consequence, little direct runoff flow from one field to another was observed (Fig. 7). For the other 40% of fields of the catchment, the most important sources of run-on are: footpaths, diversion ditches and cabbage furrows (Fig. 7). Foot paths are by far the most important cause of run-on, as they are often located above or in the middle of the fields.

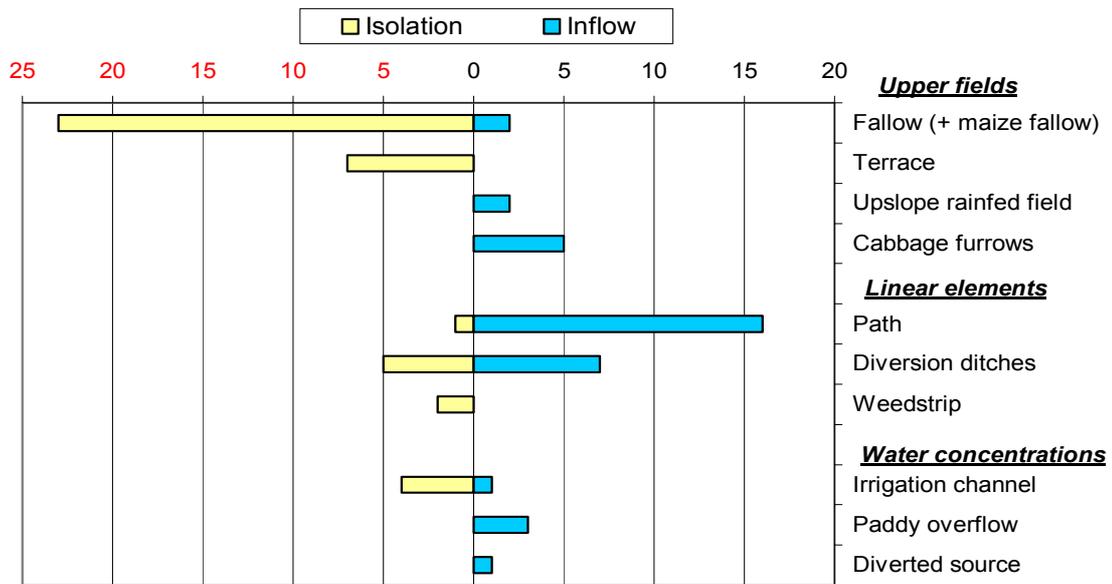
Figure 7. Impact of land use above agricultural fields on either hydrological isolation or runoff inflow at fields in the Dze Donglo catchment during the 1995 rainy season (Pakha village, Chiang Rai Province, northern Thailand).

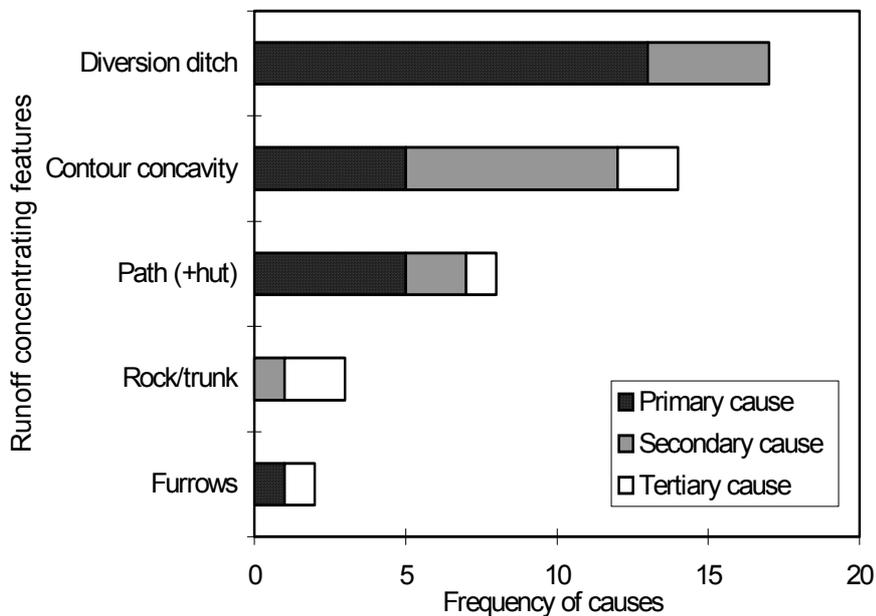
Figure 8. Frequency of runoff concentrating features leading to gully development in the Dze Donglo catchment during the 1995 rainy season (Pakha village, Chiang Rai Province, northern Thailand).

Runoff concentration within fields: Contour concavity is an evident landscape property that leads to runoff concentration. The minimum contour concavity measured to generate a gully was 40°, but an increased risk was observed with increasing contour concavity. However, man-made linear features in the landscape were more important for gully development than contour concavity at the Dze Donglo catchment (Fig. 8). This is a consequence of the relative intense land-use in the steep catchment. The linear features responsible for gully concentration, in declining importance, are: diversion ditches (DD), sloping footpaths, and furrows.

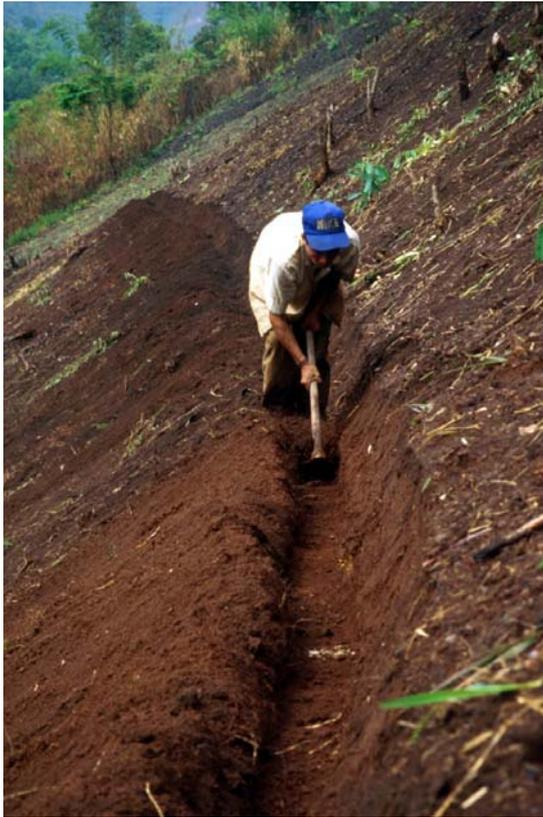
Figure 9. Diversion ditches are dug at steep field parcels to protect them from runoff inflow (Pakha village, Chiang Rai Province, northern Thailand).

Diversion ditches (Fig. 9) are a popular measure to control runoff discharge on the steep slopes of Pakha (average slope gradient of fields with DD's was 56%, S.D.= 8%). A total of 63 diversion ditches with a total length of 1.4 km were observed in the 25 ha of cultivated land (i.e. 5.6 km DD/km<sup>2</sup> cultivated land). Most DD's were found to be quite effective in draining excessive runoff out of the fields. Only when the ditch gets clogged by too much sediment (either from eroded soil clods or weeding deposits), runoff can break through the ditch wall and create a new gully at the clogged point. Farmers always try to make the diversion ditches in such a way that they will end in a stream, an existing gully, a forest, or a fallow. If the fallow vegetation is dense enough, runoff can be slowed down and sediment will be trapped. However, when a proper buffer or drain is lacking, a diversion ditch result in a relocation of a gully (or a number of rills) to a location where it cannot, or cause limited, harm to the crop.

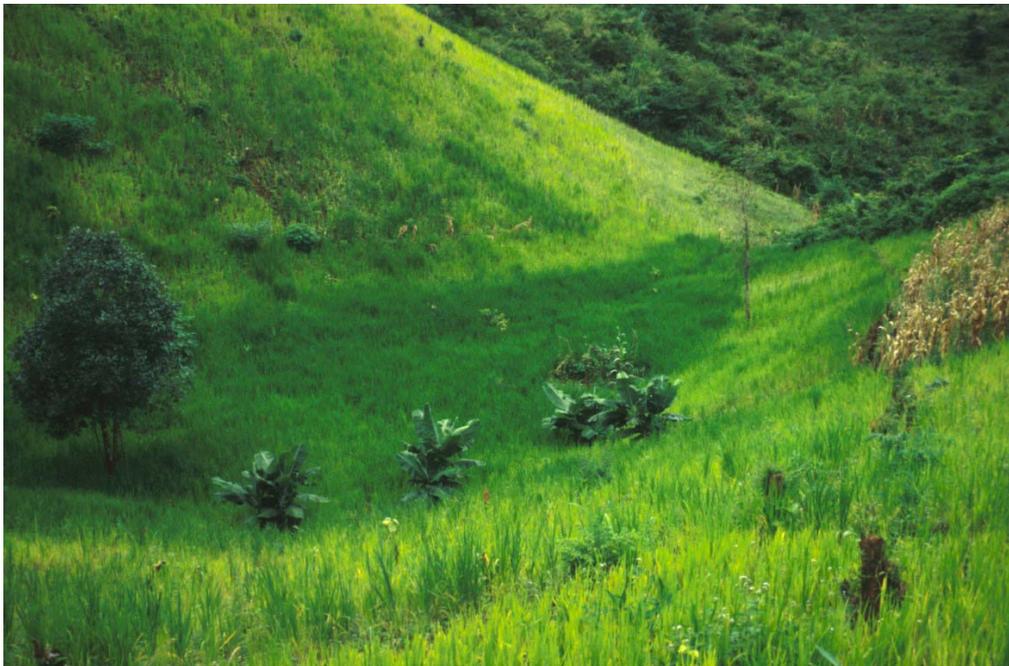
Figure 10. A sediment trap at the bottom of an upland rice field (Pakha village, Chiang Rai Province, northern Thailand).

Outflow from about 57% of the fields in the catchment is retained, at least temporarily, in sediment traps (Fig. 10). This means that a large fraction of the sediment originating from rainfed fields is deposited inside the catchment. It may take years, or even decades before they can reach the hydrological network. The most important sediment traps in the catchment are dense and long fallow land (for 25% of the fields), terraces (19%), and lower fields (13%). Thanks to fallow land, sediment sink areas can be found along the steep valley slopes. This process was confirmed during soil profile descriptions, which showed that colluvial sedimentation took place on slopes up to 60%. This is not exceptional as Moeyersons (1990) described colluviation in grassland on slopes up to 78% in the Rwandan hills.
