DGAC study n° 06/084/MQ/FIN

Research into non-destructive compression crack detection methods for wood structures

Final Report

CIRAD-Dist Unité RELIGIAQUE Baillarguet

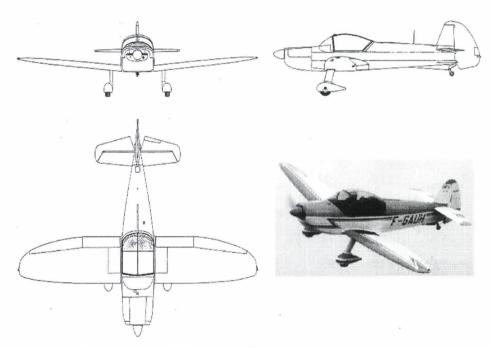
CAP 10 (Source: http://rafaero.free.fr/cap10.html).

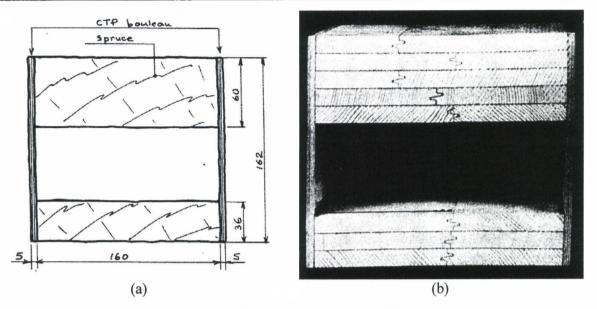
Fig.3: Sketch (a) and photograph (b) of a section of a CAP10 spar (Klinka, 1988).

In the specific case of the CAP10, the spar consists of two chords in Sitka Spruce (*Picea sitchensis*) and two webs in birch plywood (*Betula pendula*) 5 mm thick (Fig.2 and Fig.3-a, b). The chords are obtained by lengthwise (mitre) joints, transverse joints (see Fig.3 - b) and by bonding 12mm thick planks - 5 for the upper chord (upper surface) and 3 for the lower chord (lower surface). The cross-section of the chords is not constant along the length (Fig.2).

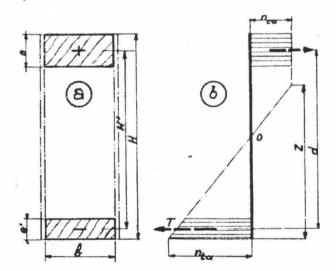
Fig. 4: Distribution of normal stress in the section of a spar (a) cross-section of the spar, (b) associated distribution (Vallat, 1945).

It is generally considered that, when an in-plane bending moment is applied to a spar, the chords experience both tensile and compressive stress (Fig. 4), and the shear stress is taken up by the two plywood webs subjected to shearing (Klinka, 1988; Vallat, 1945).

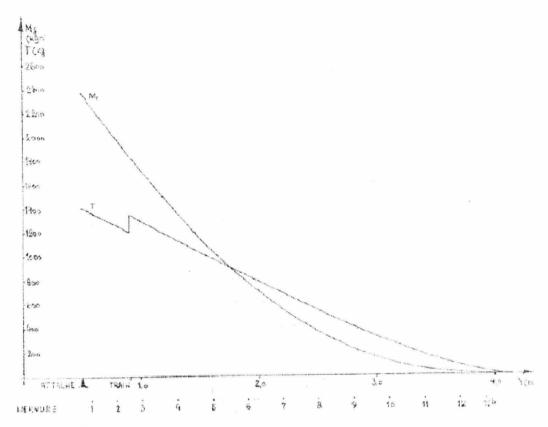
Fig. 5: Shearing stress and bending moment in a fixed-free beam.

24000 N.m (the limit moment is 36000 N.m. Klinka, 1988). The longitudinal stresses, which are functions of the bending moment are maximum at the wing root (Fig. 5).

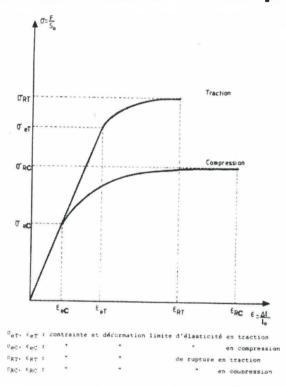
Fig. 10: Schematic figure of stress-strain (traction and compression) diagram for solid wood in the longitudinal direction (Guitard, 1997).

The difference in the mechanical behaviour of wood under traction and compression in the longitudinal direction is illustrated in Fig. 10. The tensile curve shows an approximately linear zone referred to as the elastic zone followed by a non-linear zone referred to as plastic zone, which leads to tensile failure. The tensile failure of wood accounts for its "brittle" nature. The compression curve shows the same type of pattern as the tensile curve but with the plastic zone being more marked. The compression failure of the material accounts for its "ductile" nature. (Guitard, 1997). The tensile failure limit is greater than the compression

failure limit; with the ratio of tensile to compression being approximately 2 (Pluvinage, 1992).

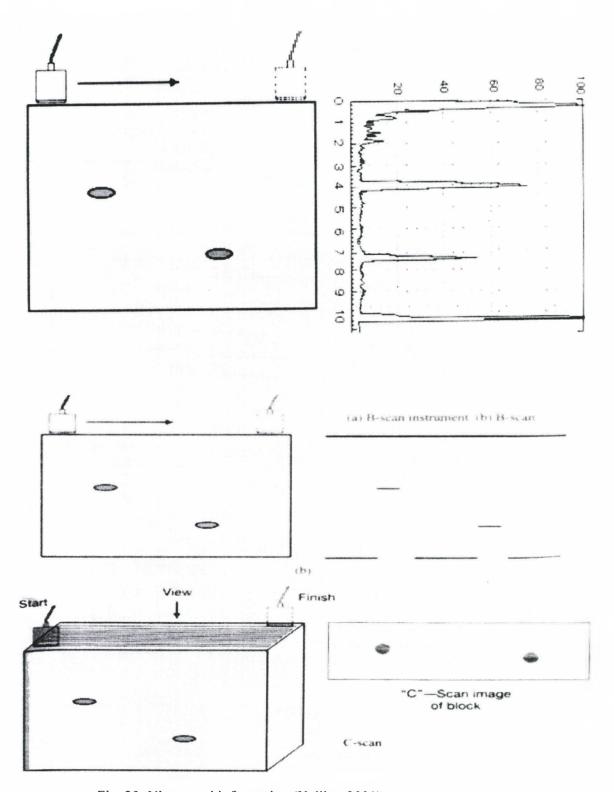
Fig. 29: Ultrasound information (Hellier, 2001).

The echoes are analysed on a screen by the inspector or processed in a measurement system for automatic installations. This method highlights discontinuities in mechanical properties found inside the material. There are several methods available for viewing the information obtained (Fig. 29). Typically the A Scan gives a direct view of the energy received; the B Scan gives a cross section of the tested component; the C Scan gives a map of the tested object. (Hellier, 2001). There are also several methods available for testing the component - transmission or reflection (Fig.30). (Shull, 2002).

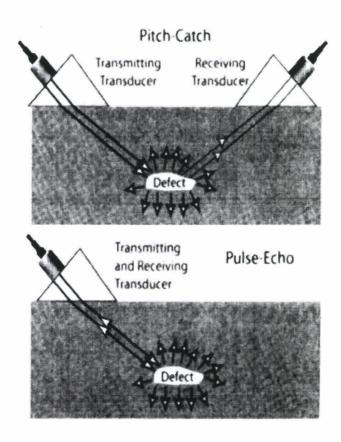
Fig. 30: Transmitting and receiving transducers directed for a test (Shull, 2002).

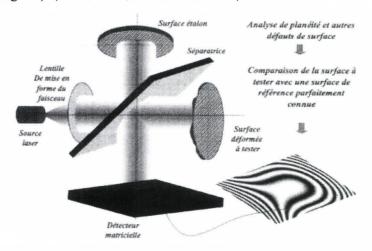
Fig. 38: Principle of interferometry as per Brun (2006).

Optical holographic techniques measure surface deformation of the tested objects. Deformation is measured by comparing the wave front of a light beam after it reflects from the tested object with the wave front of this same object recorded previously on a hologram, in a reference configuration (Fig. 38). The light used to illuminate the surface of the specimen must be coherent and monochromatic. Hence a laser is generally used as the light source. High resolution film is another requirement for holography. A defect can be detected if an abnormal surface deformation is created around it, when the object is subjected to a strain (Fig. 39). (Brun, 2006; Diederichs, 2006).

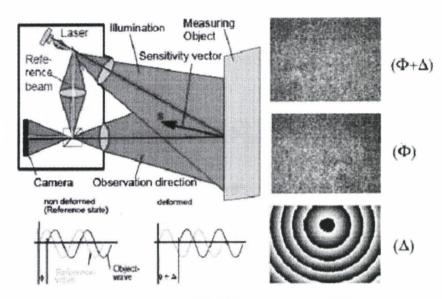
Fig. 40: Principle of holographic TV (ESPI) as per Ettemeyer (2004).

Speckle interferometry has been invented to overcome the deficiencies of holography in the interferometry field with respect to the recording medium (halide plates and films, followed by thermoplastic films). Unlike the standard holographic interferometry, speckle interferometry makes use of CCD cameras to calculate and view the displacement fields of an object (Fig. 40). (Diederichs, 2006).

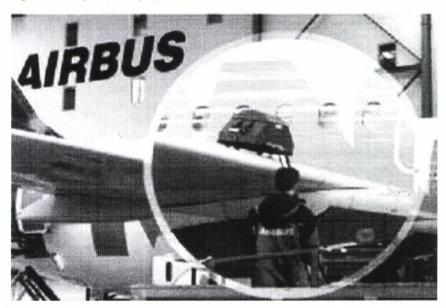
Fig. 41: Example of an industrial application for shearographic technique (Huber, 2006).

Speckle interferometry is highly suitable for industrial applications (more compact and more easily transportable instruments, less expensive, almost real time digital processing of data etc.) and has therefore developed very rapidly during the last few years and is progressively replacing existing holographic non-destructive testing systems (Fig. 41). Shearography and holographic TV (ESPI) are component elements of the several *speckle* interferometry techniques used. These techniques which are without contact, full field and almost real time, can measure displacements of the order of a few nanometres between two successive states of an object. (Ettemeyer, 2004; Huber, 2006).

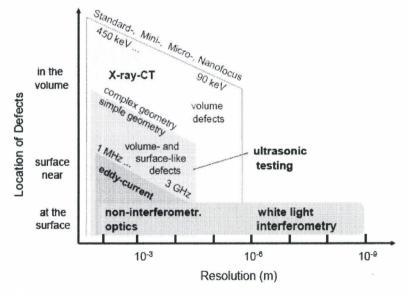
Fig. 45: Comparison of 'X-ray', 'Ultrasound', 'Eddy current' and 'Optical measurement' methods based on the location of the detectable defect and the spatial resolution. As per: Bergmann R.B., Bessler F.T., Bauer W. (2006), "Non-Destructive Testing in the Automotive Supply Industry - Requirements, Trends and Examples Using X-ray CT", 9th European Conference on Non-Destructive Testing, 25-29 Sept., Berlin, Germany, http://www.ndt.net/.

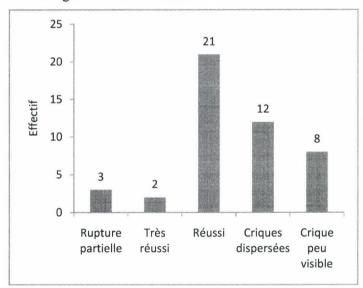
Fig. 49: Distribution of the size of damage (visual examination of the cracks).

Fig. 104 shows the comparison between visual classification of cracks (classification given in Fig. 49 and Table 4) and the failure stress average per visual class. This Fig. shows the absence of a relationship between the subjective visual estimation and the severity of the mechanical damage associated with the crack. If a relationship existed, the failure stress would be very low in the case of a partial failure and would then increase up to a maximum in the case of a less visible crack.

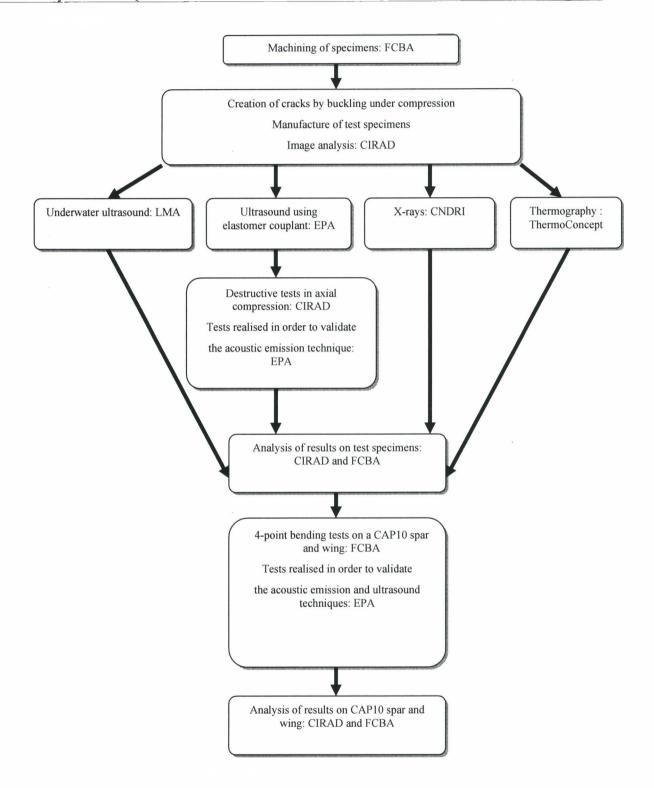
Fig. 50: Sequence of research activities.

The selected non-destructives methods are: ultrasound, acoustic emission, image analysis, X-rays and/or gamma rays and thermal infrared. The distribution of research activities and organisation is shown in Fig. 50.

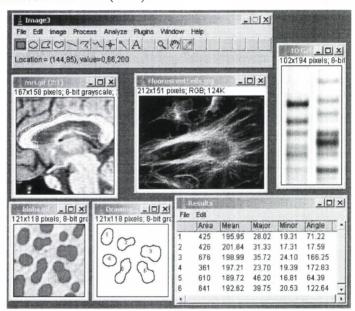
Fig. 51: Example of imageJ user interface available at http://rsb.info.nih.gov/ij/docs/concepts.html.

ImageJ offers several standard image processing functions (Fig. 51): display and adjustment of the grey level histogram, noise suppression, lighting correction, contour detection, direct-inverted Fourier transform, threshold, logical and arithmetic operations between images and in general any other linear transformation by customized mask definition. Processes stemming from mathematical morphology are also available such as erosion – dilatation. ImageJ also helps to count particles, evaluate their aspect ratio, measure different magnitudes (distances, surfaces etc.), and extract contour data for example.

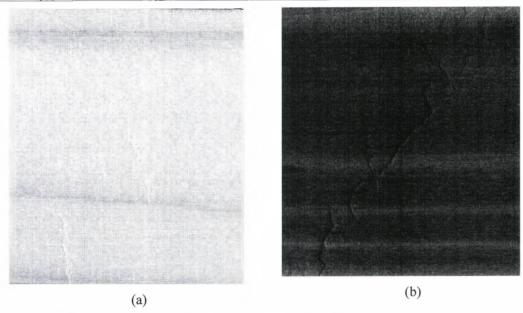
Fig. 52: Conversion of the original image to (a) reversed 8 bit image (b) a grey level image (B530/49).

The results are presented as per the example of specimen B530/49. The colour image is converted into an 8 bit grey level image. This image is then converted to negative (Fig. 52). Wrinkling, the distinguishing feature of a crack, then becomes clearly visible.

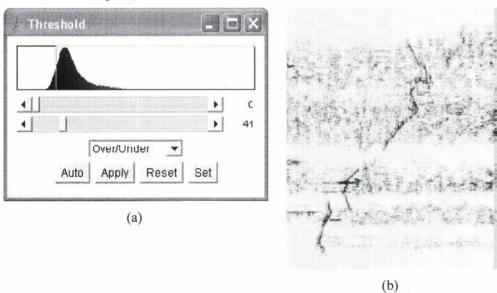
Fig. 53: Threshold adjustment (a) of the reverse 8 bits image (B530/49) and result (b).

A threshold is then defined from the grey level histogram for highlighting the crack contour (Fig. 53).

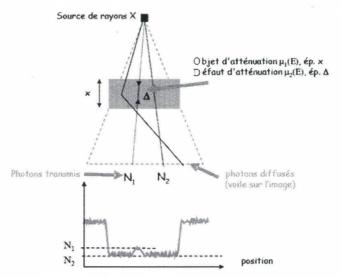
Fig. 62: Schematic diagram for testing by X-ray transmission

Imagery by X-ray transmission corresponds to the medical technique of radiography for obtaining an image of the inside of an object. The contrast achieved in the images depends on the variations in attenuation of the object (which stems from the variations of both density and atomic number i.e. the chemical composition) but also on the differences in thickness. The greater the variation (in attenuation and/or thickness) in the direction of the incident beam, the greater the contrast (Fig. 62).

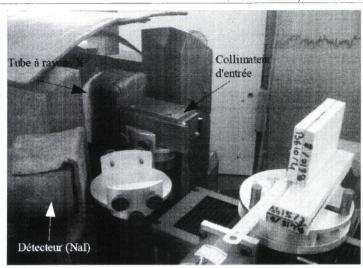
Fig. 65: Experimental measurement rig using Compton X-ray diffusion. The sensor is shielded by lead. The X-ray tube is also surrounded by lead.

Geometric configuration requires access only on one side of the component, which makes it particularly attractive for the inspection of acrobatic aircraft. However it is a slow testing process taking into account the fact that measurement is carried out one point at a time and requires scanning of the component. The sensitivity of the method is also directly linked to the size of the collimators, which is inversely proportional to the quantity of signal received. The experimental measurement rig is shown in Fig. 65.

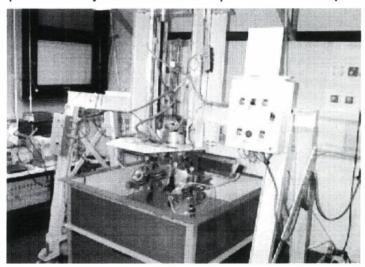
Fig. 70: View of ultrasound scanner at LMA (photos LMA).

An ultrasound scanner (Fig. 70) has been used so as to provide a variety of possibilities of examination in ideal laboratory conditions. Water is the couplant medium. The scanner consists of:

- A mechanical robot for handling ultrasonic waves (transducers) with 8 degrees of freedom (2 linear displacements in X, Y, Z and 2 probe/object concentric rotations).
- An electronic control bay for the robot movements.
- An acoustic signal emission, transmission and processing system.
- A computer for the synchronisation of displacements and acquisitions.

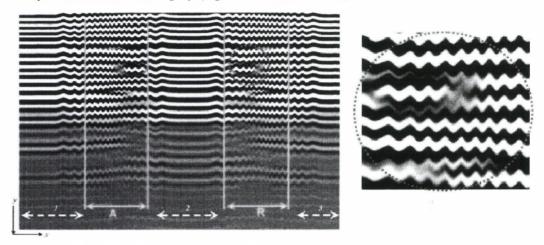
Fig. 77: Example of a to and fro B-Scan representation on a crack zone.

Zones A and R in Fig. 77 represent the to and fro movement around the crack zone. Zone 1 corresponds to the initialisation of the test where motor vibration (acceleration and displacement) is shown by the oscillations. Zone 2 corresponds to the transition or the pause between the to and fro paths. There is no sensor movement. Zone 3 corresponds to the slowing down and the end of the test. The variations viewed in the form of waves correspond to the acceleration of the motor shown here by the vibration of the specimen and or the sensor itself.

The blue colour zone in Fig. 77, which represents an anomaly (acoustic impedance failure) is a zone with a structural defect; namely a compression crack in this example. Since ultrasound propagation velocity in wood is known, it is possible to evaluate the depth corresponding to the defect (4 mm deep in this case, Fig. 78).

Fig. 77 shows the result obtained by a normal reflection test in B-Scan. In this figure, time is shown on the ordinate axis (equivalent to the sounding depth). The time elapsed during the test is shown on the abscissa axis (equivalent to the depth examined under the specimen surface). The amplitude of the signal received is represented in levels of grey (signals are not rectified).

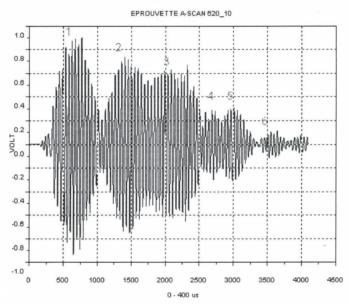
Fig. 89 gives an A-SCAN representation of the transmitted signal for specimen 620_10 . The ultrasound signal propagates in the material without any significant attenuation. The intrinsic characteristics of elastomer type sensors explain the signal form that is relatively less dampened. 5 to 6 successive lobes can be seen on this A-SCAN over the $400~\mu s$ of propagation of the ultrasound signal.

Fig. 89: A-SCAN ultrasound signal obtained on a wood specimen (reference 620/10).

The transducers are held on the surface with a constant pressure and the gain is adjusted automatically for each specimen. The specimens are theoretically considered to have the same characteristics but a comparison of the A-SCAN signals obtained highlights significant differences in the signal at the level of the last lobes.

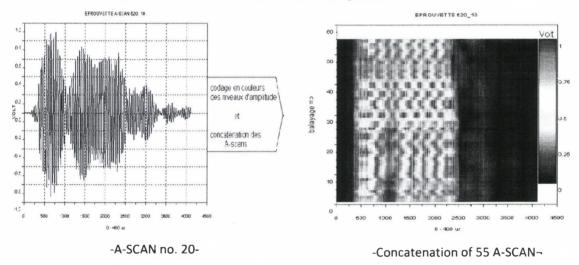
Fig. 90: Principle for obtaining a B-scan map for specimen 620/10.

Each horizontal line of the resultant B-scan (Fig. 90) thus corresponds to an A-SCAN, the amplitudes of which are colour-coded. The abscissa axis of the B-scan corresponds to the length of the A-SCAN recorded (400 μ s) and the ordinate axis to the chronological storage order of the A-SCANS. Fig. 90 shows a B-scan carried out on specimen 620/10 by recording 55 successive A-SCANs. The signal amplitudes are colour coded (from blue to red for minimum and maximum).

The Pocket AU generates C-scan maps for a specimen but the geometrical form of the specimens and the overall dimension of the scanner do not allow this type of 2D mapping. To obtain a B-scan, a full scan of the specimen is required as well as the storage of each A-SCAN (manual operation) as and when the scanner advances. The files stored in memory are then compiled and traced so as to obtain a concatenation of all the A-SCANS (Fig. 90).

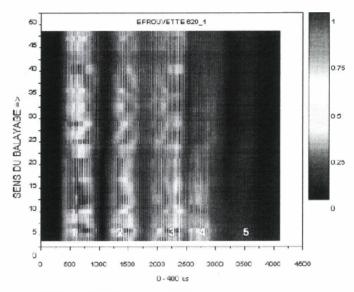
Fig. 91: B-scan mapping of the test specimen 620/1.

A total of 15 specimens were mapped in B-Scan. One specimen did not contain any damage and was tested on both faces. The other specimens all showed significant compression cracks at various positions. Fig. 91 shows the mapping of the defect free specimen 620/1. Fig. 92 shows the detection of a defect on the specimen 530/1. All the maps obtained however show different patterns and the interpretation of B-Scan mapping is very difficult.

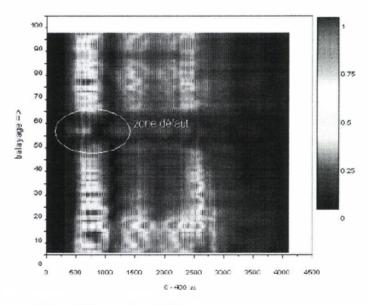
Fig. 92: B-scan mapping of the specimen 530/1.

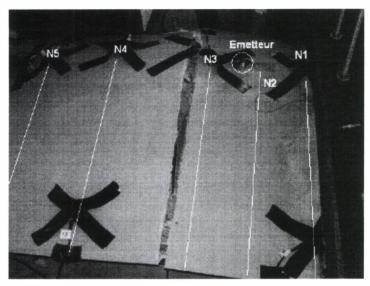
Fig. 96: View of the left wing after failure.

The failure of the left wing (Fig. 96) occurred during the last AU5 load. The evolution of the propagation time between the transmitter and the receivers, coupled on the ribs, after each load had not shown any significant variation during the test.

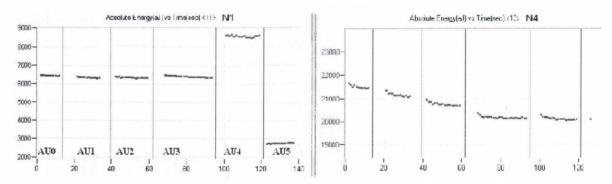
Fig. 97: Energy of signals measured during the static test for the left wing.

The analysis was made on ribs 1 to 5 for both parts of the wing. Only the results obtained with receivers N1 and N4 are shown (Fig. 97 and Fig. 98) and these show a break in the evolution of energy between times AU3 - AU4 for N1 and AU2 - AU3 for N4. This break, according to the receivers N1, is reflected by a sudden increase while the tendency had been decreasing and, for receivers N4, it is reflected by a sudden jump during energy decrease. It is however impossible to determine the location of failure on the wing. Thus ultrasound transmitters - receivers coupled to the wing skin - would enable the detection of a structural modification to the skin but not to the spar.

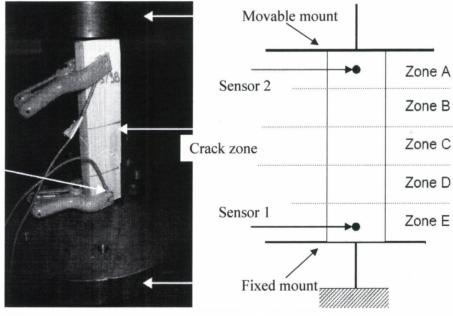
Sensors EA

Fig. 99: Axial compression test tested by Acoustic Emission.

A total of 34 test specimens were tested in axial compression until failure (NF B 51-007, Sept. 1985). The test rig is shown in Fig. 99. The characteristics of each test specimen are described in Table 6. The location of the cracks in this table is obtained by visual observation and can only be used to subsequently compare the location of the initial cracks with respect to the final failure. The letters A, B, C, D and E refer to the division of the length into five zones (Fig. 100).

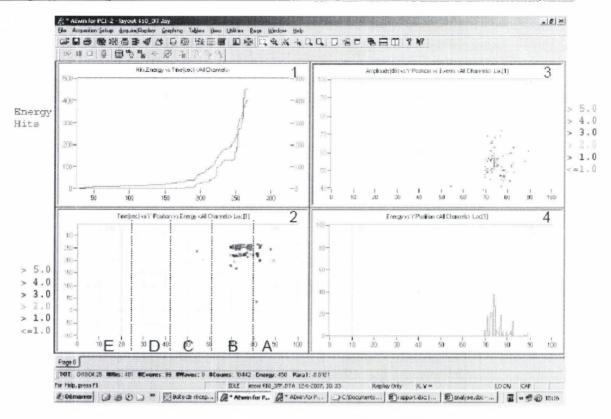
Fig. 101: AE activity and location of events-test specimen B410/37.

Fig. 101 is divided into 4 parts:

In this example, there is average acoustic activity with a few bursts right from the beginning of the test. The intensity shows a first point of inflexion after approximately 160 s of testing followed by a second at around 250 s. Very few events are located before 200 s and the events are concentrated in zones A and B, which corresponds to the location of the initial crack and that of the failure in the test specimen.

A testing example is given in Fig. 101 for specimen B410/37 of batch 1. For this specimen, the distance between the sensors was 75 mm. In order to filter ambient noise, the results take into account only bursts with amplitudes greater than $40~dB_{\rm EA}$.

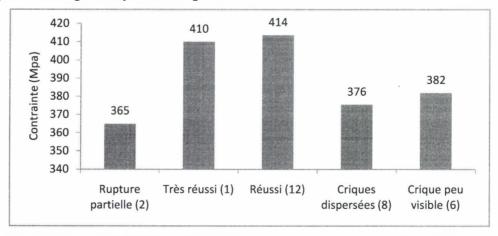
Fig. 104: Comparison between the visual classification of cracks and average failure stress (total number per visual class in brackets).

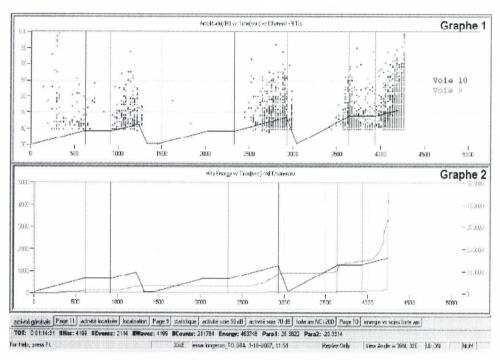
Fig. 107: General Acoustic Emission activity. Component 1: Amplitude of bursts as a function of time with display of loading cycle. Component 2: Number of bursts cumulated (in red) and cumulated energy (in green) as a function of time with display of load cycle.

Fig. 107 shows that at the very first loading, large amplitudes were detected by sensor 9; however emission became correctly stabilized at a plateau. During the second loading cycle (from 0 to 80000 N), emission resumed at around 43000 N, i.e. before reaching 60000 N (the load reached during the first cycle). This tends to show that the structure was damaged since the Kaiser effect was no longer followed. During the last cycle (from 0 to 100000 N), the first bursts were once again detected starting from 43000 N while the load previously attained was 80000 N. During the plateau at 80000 N, there was no stabilisation of emissions suggesting significant damage to the structure.

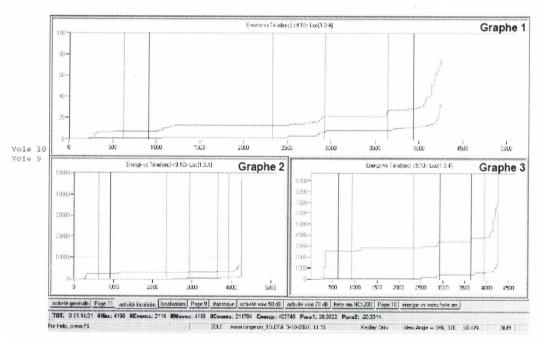
Fig. 108: Acoustic Emission activity and intensity per channel. Component 1: Number of events cumulated per channel as a function of time. Component 2: Energy cumulated per channel as a function of time. Component 3: Enlargement of component 2.

Fig. 108 shows the acoustic activity and intensity per channel. Sensor 9 detected many more events than sensor 10 particularly during the first cycle.

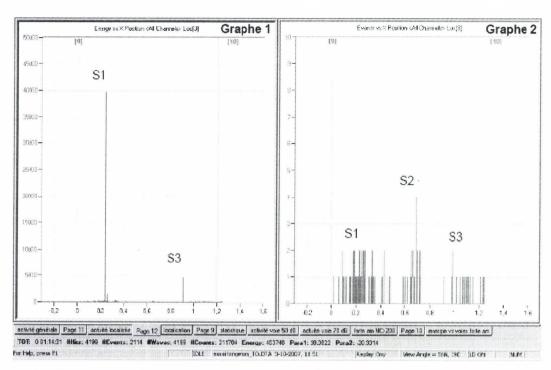
Fig. 109: Linear location of energy (1), linear location of events (2).

Fig. 109 shows perfectly the existence of three sources S1, S2 and S3. Source S1 was the most energetic.

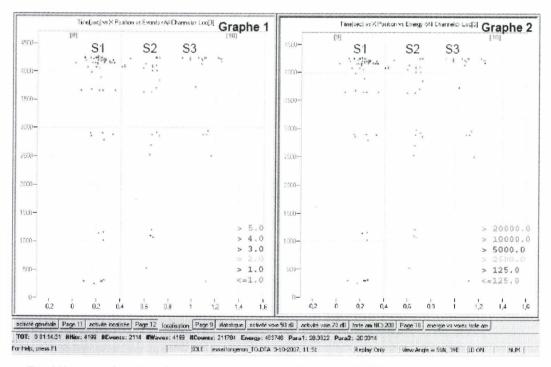
Fig. 110: Linear location of events a function of time (ordinate axis) (1), linear location of energy as a function of time (ordinate axis) (2).

Fig. 110 shows the appearance and the evolution of sources with time. S1 and S2 appeared on the very first loading cycle while S3 appeared during the second cycle. S1 and S3 correspond to the position of the cracks identified.

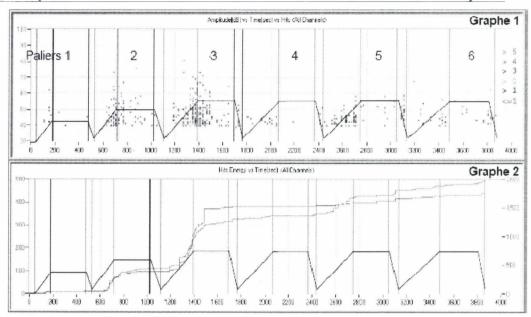
Fig. 117: General activity during static tests (SAMOS). Component 1: Amplitude of the bursts as a function of time with visualisation of the load cycle. The colour scale represents the number of bursts cumulated. Component 2: Number of bursts cumulated (in red) and energy cumulated (in green) as a function of time with visualisation of the load cycle.

Fig. 117 shows that the bursts were detected naturally while ascending to the second and third plateau, with emissions stabilising quite rapidly at plateaus. At plateau 4, preceded by a load of 12000 N, only a few small amplitude bursts were detected. Despite a load increase to 24000 N before plateau 5 and 36000 N before plateau 6, larger amplitude bursts were nevertheless detected during these phases, refuting the Kaiser effect and indicating the existence of structural damage.

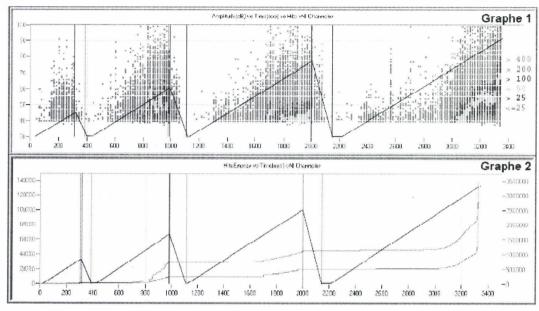
Fig. 118: General activity during the damage test (SAMOS). Component 1: Amplitude of bursts as a function of time with display of the loading cycle. The colour scale represents the density of bursts. Component 2: Number of bursts cumulated (in red) and energy cumulated (in green) as a function of time with display of the loading cycle.

Fig. 118 shows that bursts were detected during all loading phases. The first bursts of very large amplitudes appeared from the second load onwards. The Kaiser effect stipulates that no bursts should be detected before reaching the maximum force previously applied. This Kaiser effect was not fully respected during the third and last loading as the first bursts were detected at 22000 N (previous plateau: 24000 N) and 33000 N (previous plateau: 36000 N) respectively. The fact that the Kaiser effect was not followed shows that the structure was damaged.

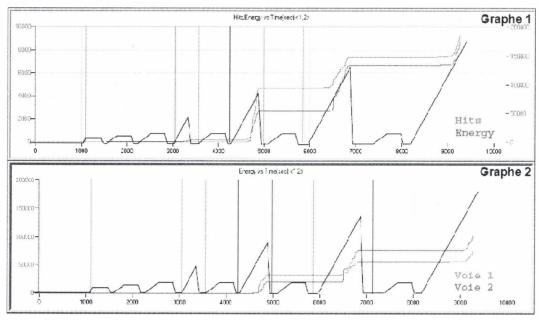
Fig. 125: General activity (Pocket EA). Component 1: Amplitude of bursts as a function of time with display of the load cycle. The colour scale represents the number of bursts cumulated. Component 2: Number of bursts cumulated (in red) and energy cumulated (in green) as a function of time with display of the load cycle.

Fig. 125 gives real time results that are similar to the results previously obtained: burst detection mainly during loading to 12000 N, 24000 N, 36000 N and until failure. Bursts were also detected during plateaus following loading to 24000 N and 36000 N.

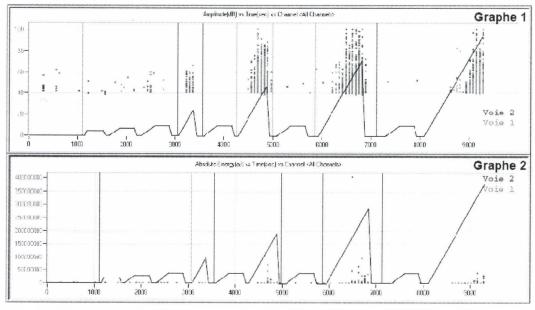
Fig. 126: Reception of bursts per channel (Pocket EA). Component 1: Amplitude of bursts as a function of time with display of the load cycle. Component 2: Energy of bursts as a function of time with display of the load cycle.

Fig. 126 also corroborates the results obtained previously by showing that sensor 1 (right wing) detected the bursts of highest amplitude up to 24000 N then

from the time of load increase to 36000 N, it is sensor 2 (left wing) which detects the highest energy bursts. Early detection of very high energy bursts during the second or third damage cycle could be used as a criterion for damage.
